SHAKE AND/OR SHUDDER DURING LIGHT THROTTLE ACCELERATION BETWEEN 40 AND 128 KM/H (25 AND 80 MPH) AT A STEADY STATE

#19-NA-018: Shake and/or Shudder During Light Throttle Acceleration Between 40 and 128 KM/H (25 and 80 MPH) at a Steady State - (Aug 25, 2021)

Attention: This bulletin only applies to Mexico and Export Regions outside of the U.S. and Canada.

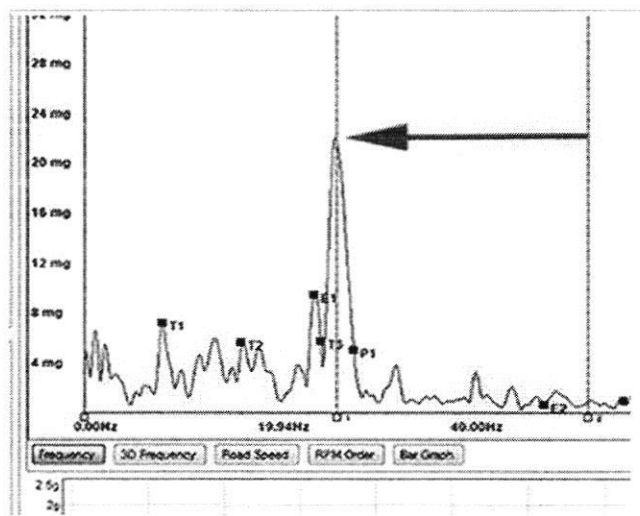
To confirm TCC Shudder, record the PicoScope data while driving in 8th gear in the application specific condition above. Minimize extraneous vibration input by testing on a smooth road and correct any other known vehicle vibration issues (tires, brakes, etc.) before conducting test. If TCC Shudder is present, a vibration peak will appear (highlighted by arrow

below) within ± 2 Hz of the frequency listed in the table above. TCC Shudder vibration frequency is stationary in 8th gear. If the vibration frequency follows vehicle speed or engine speed, then it is NOT TCC Shudder.

In the above illustration, frequency and default view have been selected.

Important: Obtain a screen print from GDS or PICO Scope that shows the TCC shudder event. This screen print must be attached to the Repair Order hard copy for reference.
